MEMO

The memo dated 15 November 2021 that I prepared was prepared prior to receiving briefing on the full range of concerns raised in relation to the aggregate development that occurred this year in SE-10-23-23 W2 (Fig. 1). Specifically, there is concern about the impact of the aggregate development on recharge of the wetland situated immediately downstream (Fig. 2). Water stored in the wetland predominantly during wet spring seasons recharges nearby water wells, including municipal wells at Spring Bay. This memo discusses impacts to drainage patterns associated with the aggregate development that occurred this year.

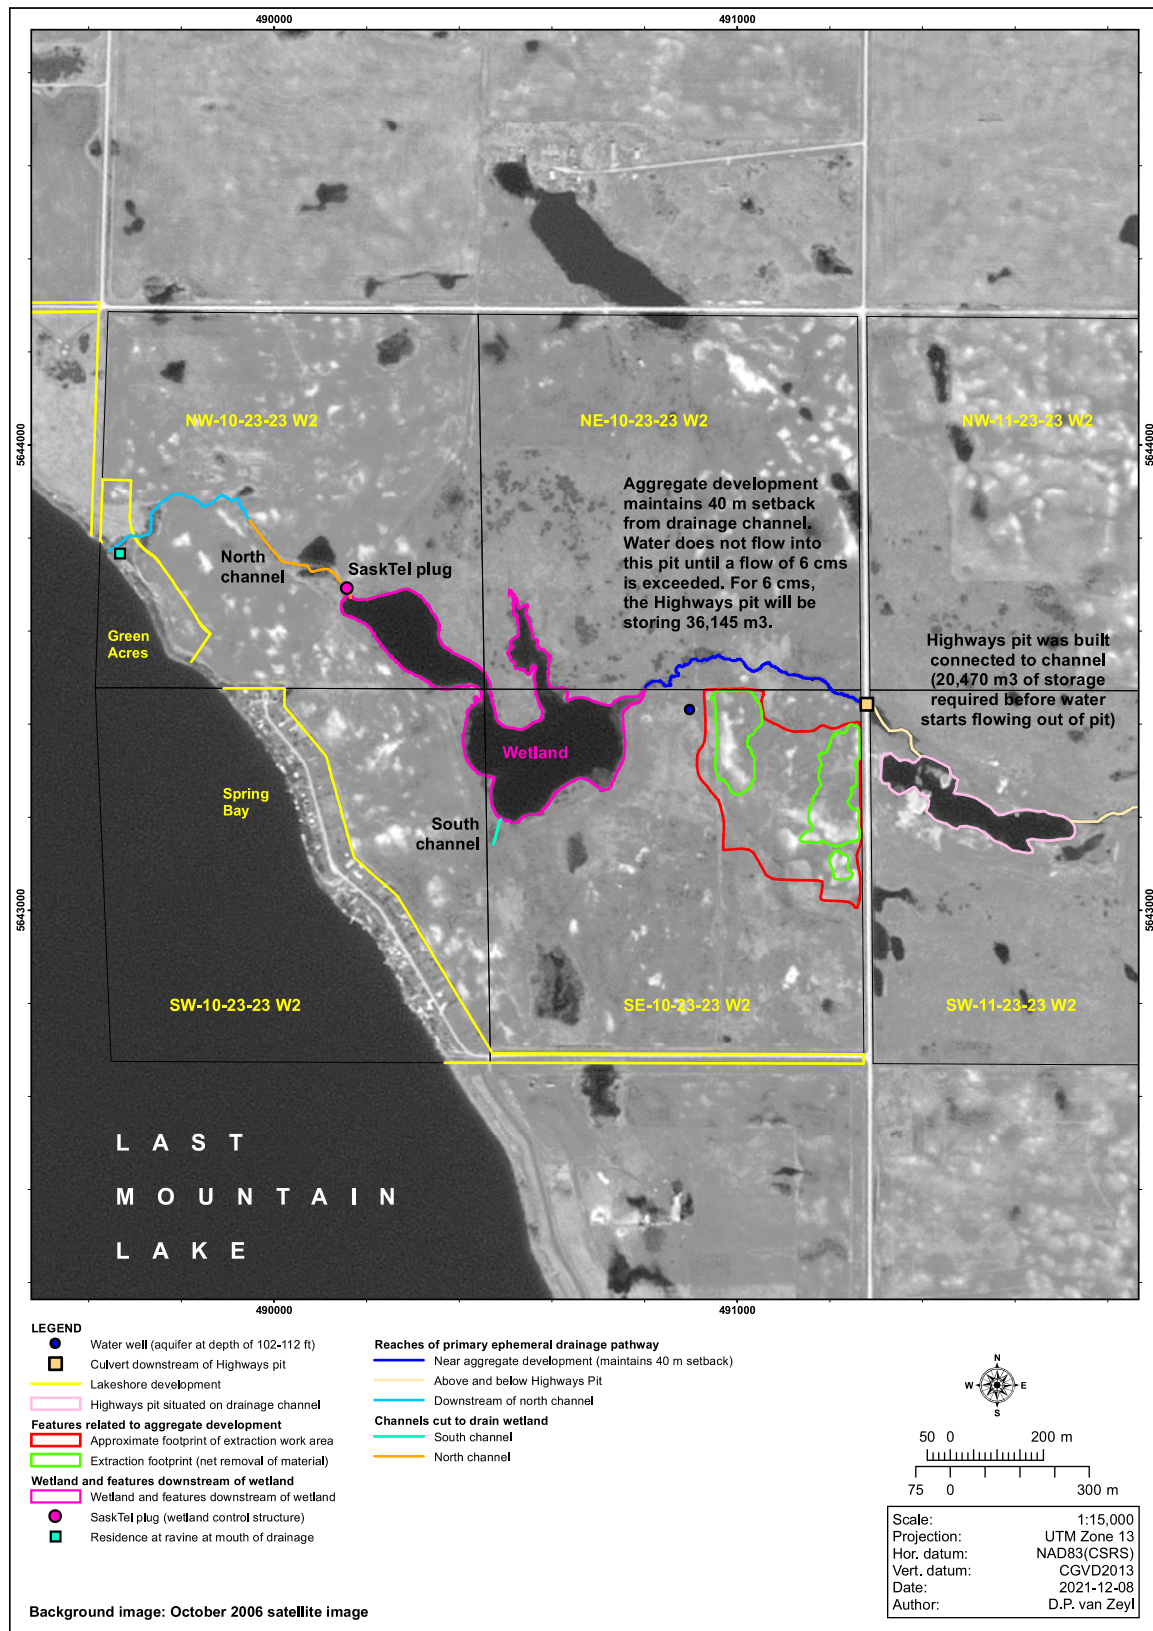
Figure 2 Overview of aggregate development and nearby features discussed in text.

Other key controls on wetland recharge include the Highways pit in SW-11-23-23 W2 and the north channel situated at the wetland outlet in NW-10-23-23 W2 (Fig. 2). These controls are unrelated to the aggregate development but should be considered so that impacts from the aggregate development can be put into perspective.

The Highways pit in SW-11-23-23 W2 (Fig. 2) was built directly connected to the ephemeral drainage channel. As a result, for every flow that occurs along the drainage channel, the depressions within the pit must first be filled before water can spill out of the pit and flow downstream. The volume of water that must be stored within the pit before downstream flow can occur is 20,470 m³. In contrast, only for flows exceeding 6 m³/s will any water be lost to the pit downstream at SE-10-23-23 W2. For a flow of 6 m³/s at the Highways pit, a volume of 36,145 m³ will be present within the pit depressions, and this volume does not include any headwater effects from the culvert downstream. A larger culvert downstream would reduce the headwater ponding effect and thereby reduce the amount of water lost to infiltration into the road embankment and into the area east of the road.

Channels have been cut in two locations to facilitate drainage of the wetland (Fig. 2), a low-level channel ('north channel') and a high-level channel ('south channel'). The channels are understood to have been built in the late 1960s or early 1970s. The north channel functions as the main outlet for the wetland. The north channel is partially blocked by a makeshift dam built sometime between 2005 and 2009 by SaskTel when an underground cable was installed across the channel (Fig. 2). The sill on the crest of this plug is estimated from the 2015 data as 500.65 m elevation, whereas full supply level on the wetland is estimated as 501.15 m elevation. As a result, if grades near the north channel were restored to their natural state, the wetland would have the capacity to store an additional volume of about 55,840 m³ (wetland area is 111,679 m²). In other words, the impact of the man-made alterations around the north channel have been for the wetland to lose the potential to store an additional 55,840 m³ of water in years when abundant moisture is available. From the satellite image analysis (Table 1), it is expected that losses of at least 55,840 m³ would have been observed in each of the wettest years since 1984, namely, 1996, 1999, 2006, 2007, 2011, 2014, 2015, 2016 and 2017. Prior to the SaskTel plug being installed, these losses would have been much larger, possibly in the order of 150,000 m³. Note that the SaskTel plug is not expected to have been engineered as a dam. Thus, there is a risk that overtopping of this structure could result in its washout and a rapid release of water that could impact the residence at the ravine at the mouth of this drainage (Fig. 2).

In summary, in terms of controls on water supply to the wetland downstream of the aggregate development (Fig. 2), the most important loss of water would appear to be outlet accentuation at the north channel. In years when water is abundant (e.g., 1996, 1999, 2006, 2007, 2011, 2014, 2015, 2016 and 2017), the wetland is losing at least 55,840 m³ of water due to outflow accentuation at the north channel. This would be the number one area to consider for improving wetland water supply and consequent recharge of aquifers in the area of the wetland. The next most important impact identified is the Highways pit in SW-11-23-23 W2, which removes 20,470 m³ of water from the stream before flow is able to continue downstream of the pit. The third most important control is the culvert downstream of the Highways pit. When the small diameter of this culvert results in headwater ponding, some of the ponded water soaks into the road embankment and into the ground surrounding the Highways pit rather than flowing downstream. In contrast, the impact of the aggregate development in SE-11-23-23 W2 on water supply to the wetland is essentially negligible when compared with the above factors. That is, water losses to the wetland from rainfall and snowmelt that used to occur on the sand hills that have now been removed at the aggregate development are in the range of 944 to 4,718 m³ per year, plus there is potential of losing 5,927 m³ at a recurrence interval in the order of 25 to 50 years (based on a discharge that has not been observed at this site in the last 38 years).

The main ways in which wetland recharge and consequent recharge of nearby aquifers can be improved are presented below in order of decreasing importance:

1. Restore north channel of wetland to natural grades
2. Reclamation of the Highways pit
3. Upgrade culvert downstream of Highways pit

Note that if the Highways pit is reclaimed so that pit depressions are removed, this will mean that more flow will be available to flow through the culvert downstream and a consequent greater probability of road overtopping. As a result, the culvert should be upgraded before or during reclamation of the Highways pit.

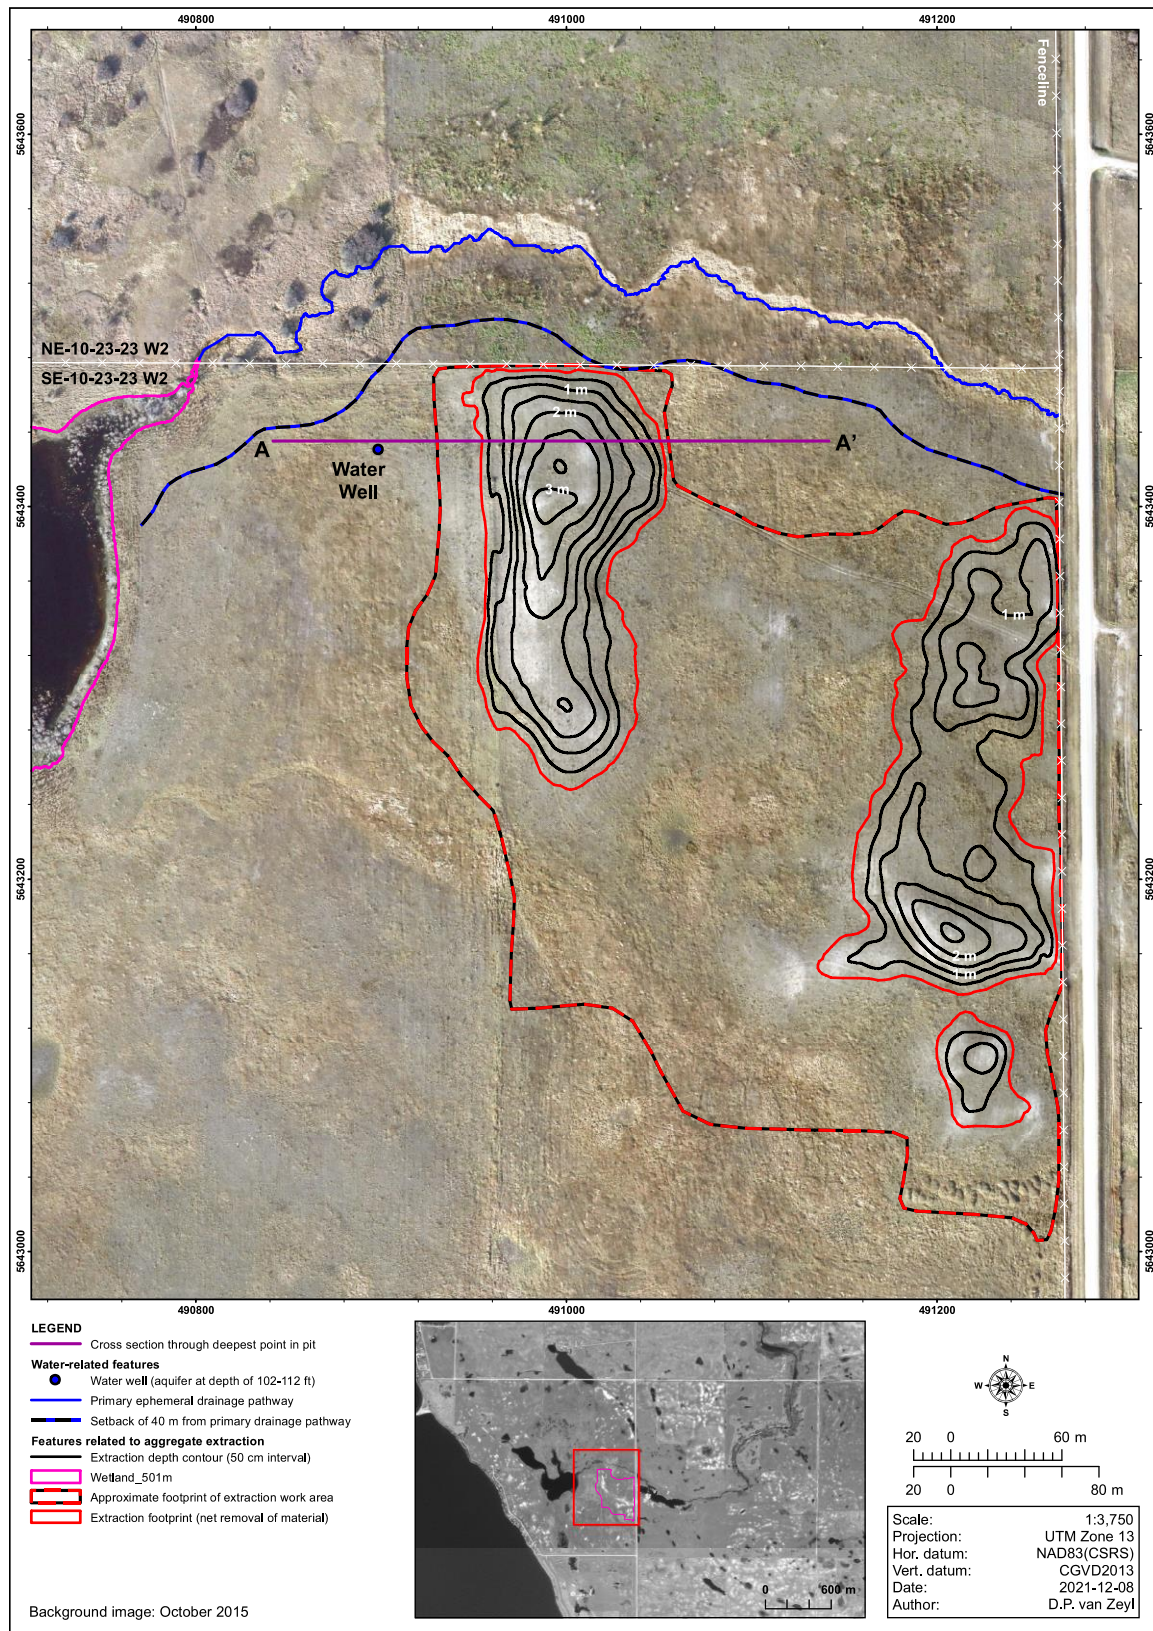
Figure 3 Map of aggregate extraction area with October 2015 background image.

As summarized in the Nov 15th memo, the aggregate development that took place this year in SE-10-23-23 W2 (herein 'the aggregate development') resulted in a net lowering of grade as measured from Oct 2015 to Nov 2021 in three relatively small areas. These relatively small areas are situated within a larger area where the aggregate extraction and processing work took place (Figs. 3-5).

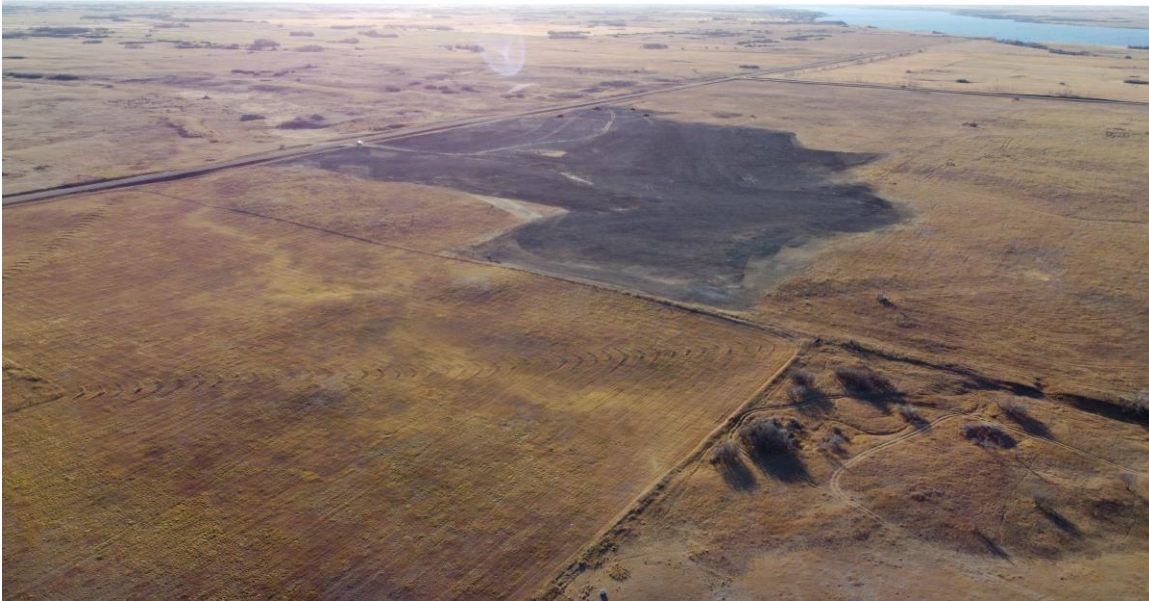
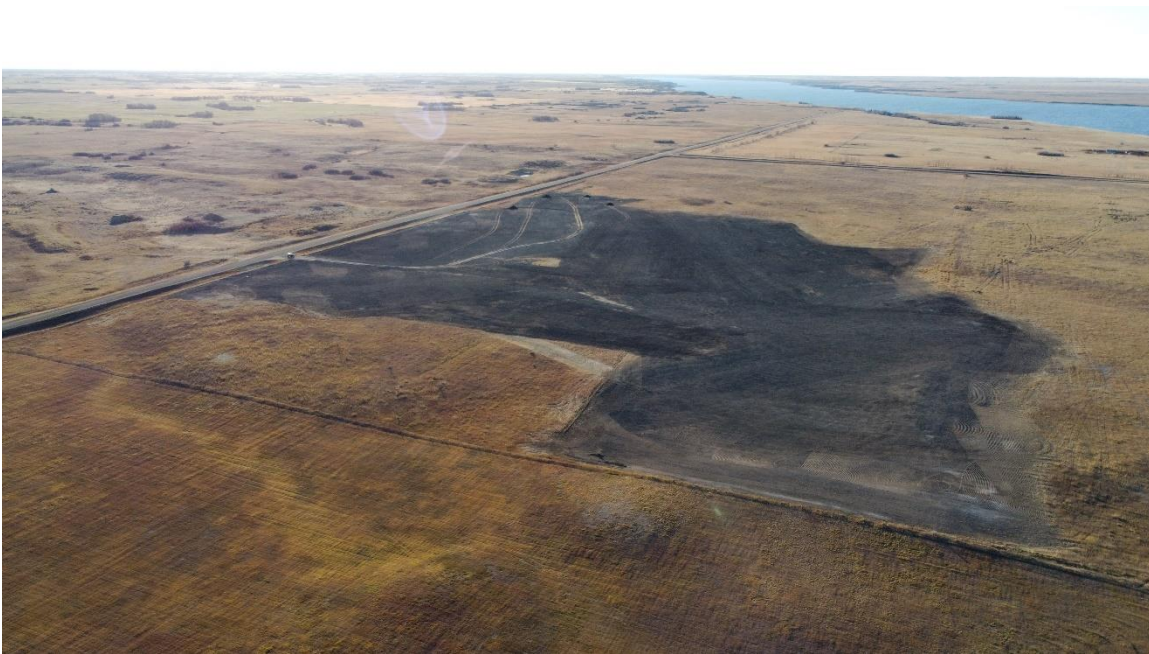
Figure 5 Oblique aerial photos showing aggregate extraction area (08 Nov 2021).

In general, that the aggregate development in SE-10-23-23 W2 was kept away from the drainage channel by a minimum setback of 40 m was a very favourable aspect of the development in terms of minimizing impacts to drainage patterns. Though it is not so much the horizontal setback that was favourable, but more so the fact that the edge of the western pit formed is 0.54 m above the nearby channel. When the detailed channel geometry at this site is considered, this means that channel flow into the extraction pit at this site cannot occur until a flow exceeding 6 m³/s occurs downstream of the nearby culvert. The return period of such an event is expected to be in the order of 25 to 50 years, without accounting for the small diameter of the culvert upstream, which will not pass a flow of 6 m³/s without road overtopping. Given that channel flow into the extraction pit is only expected during relatively large floods (i.e., larger than any observed in the last 38 years), at those times it is possible that downstream landowners marginal to this drainage system will see the situation as an overabundance not underabundance of water.

The standard to which reclamation of this aggregate development has been brought appears to be very high. It is expected that in one or two years, it will be difficult to visually identify that an aggregate development occurred at this site. If all such developments were reclaimed to this standard, it is expected that the public would have a much better impression of aggregate developments and, as a result, there would be less public outcry when one is being proposed.

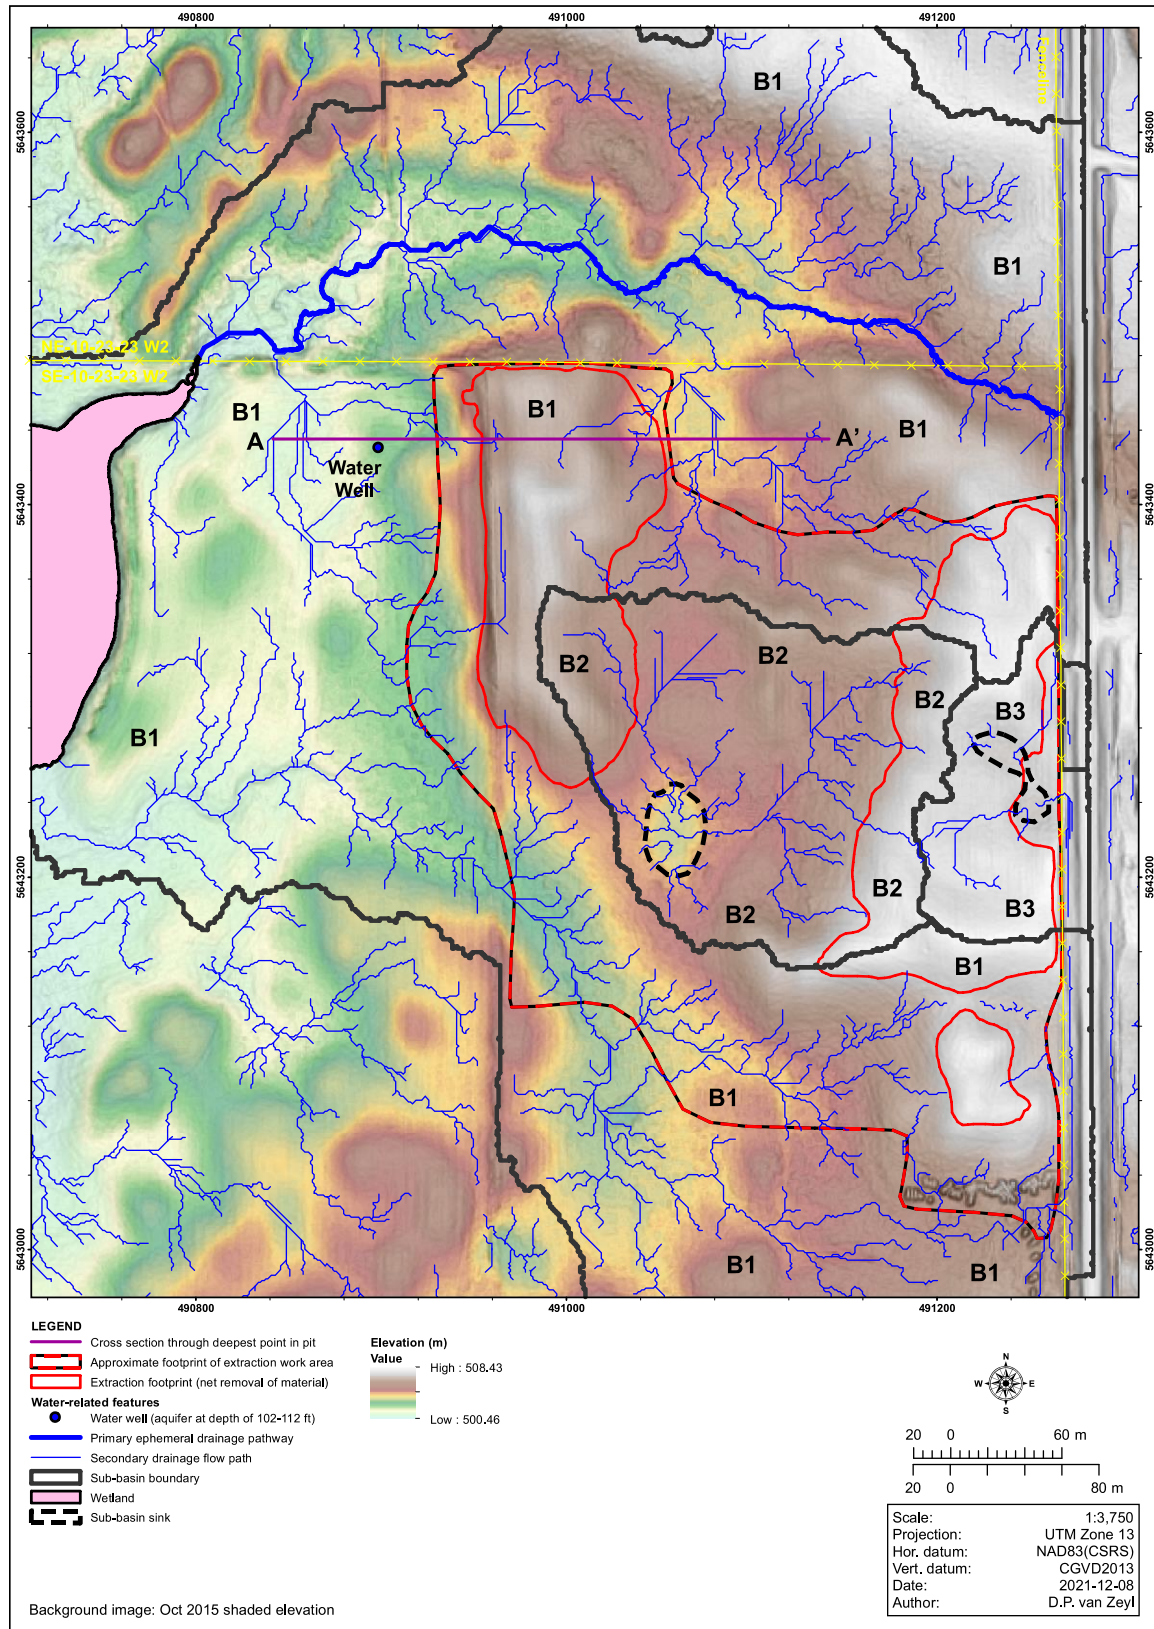
Figure 6 Map of aggregate extraction area with October 2015 topo background image.

In terms of changes in surface water flow paths following the aggregate development, changes to the layout of sub-basins can be seen by comparing Figures 6 and 7. In particular, it can be seen that in 2015, part of what later became the aggregate work area drained into the wetland (B1), whereas other parts were internally drained (B2 and B3), with flow terminating in local depressions (sinks). Following aggregate development, the area draining into the wetland was reduced by 22,466 m². For an annual precipitation of 420 mm, this would indicate a maximum possible loss of water flowing to the wetland of 9,436 m³ per year. However, as the extraction areas consisted of sand hills, and high infiltration rates would be expected for sand (e.g., 20 to 40 mm/h), a large proportion of the water available as rain or snowmelt would be expected to soak into the ground rather than runoff into the wetland. Considering the possibility of 50 to 90% infiltration, the amount of water no longer flowing to the wetland would be in the range of 944 to 4,718 m³.

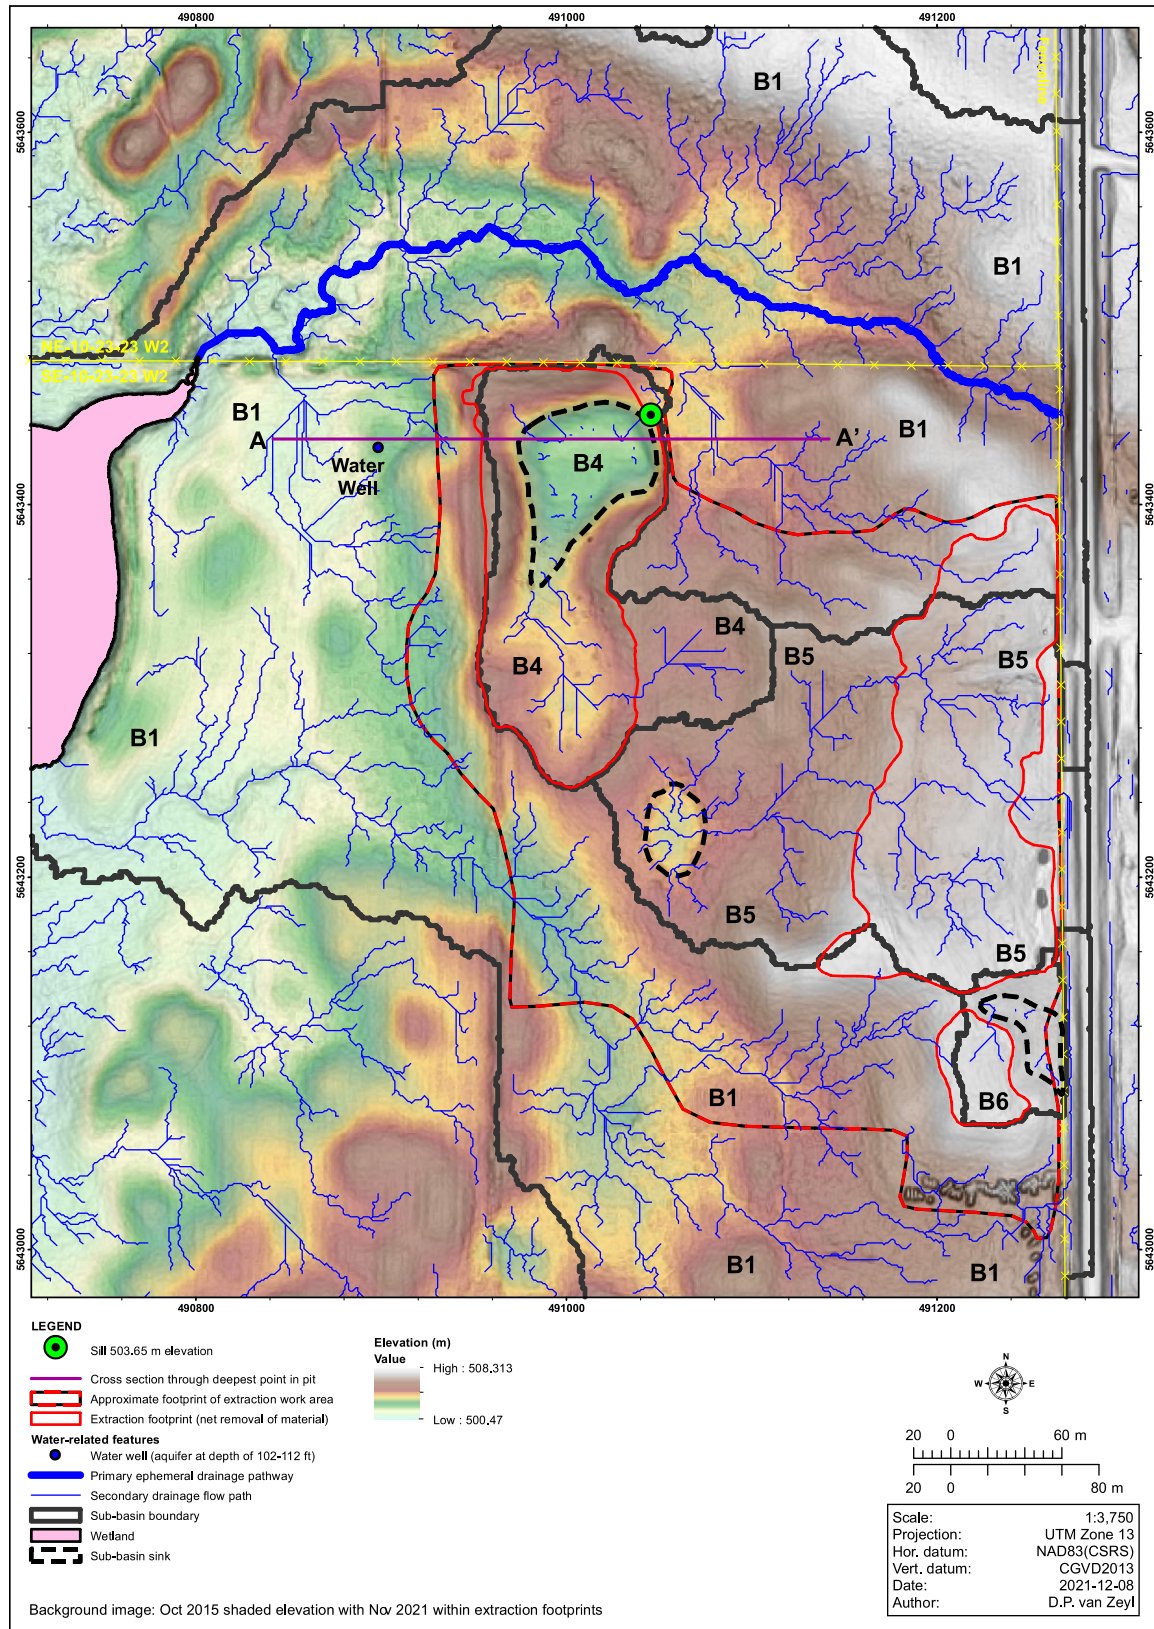
Figure 7 Map of aggregate extraction area with November 2021 topo background image.

In terms of streamflow from upstream on the primary ephemeral drainage channel, there will be a loss of water to the wetland if nearby channel flow rises to a water depth exceeding 0.54 m so that it is high enough to spill into the western of the three extraction areas. Hydraulic analysis indicated that channel flow will only flood up into that extraction area if a discharge of 6 m³/s is exceeded. For the catchment area upstream of this site, with an areal extent of about 12 km², a discharge of 6 m³/s would be estimated to have a return period of 25 to 50 years. Furthermore, given that flow along the channel immediately upstream must pass through a culvert beneath the grid road (diameter of 18 to 24 inches), a flow of 6 m³/s could not occur without road overtopping. To date, the grid road above this culvert is not known to have been overtopped, not even in any of the wettest of the 38 years assessed from the satellite image analysis summarized in Table 1. Therefore, the occurrence of a flow of 6 m³/s downstream of the culvert is expected to be a fairly rare event at this site.

If a discharge of 6 m³/s were to occur downstream of the culvert for long enough to fill the western extraction pit, the volume of water that would be stored within the pit, and thereby would not be available to recharge the wetland, would be 5,927 m³. In addition, any water soaking into the ground if the pit is filled would also be precluded from wetland recharge. The amount of water soaking into the ground within the pit would depend on the length of time that 6 m³/s is exceeded at this location. With the sand deposits having now been extracted from the pit, there is less potential for infiltration of surface water, but nonetheless infiltration would still be expected.

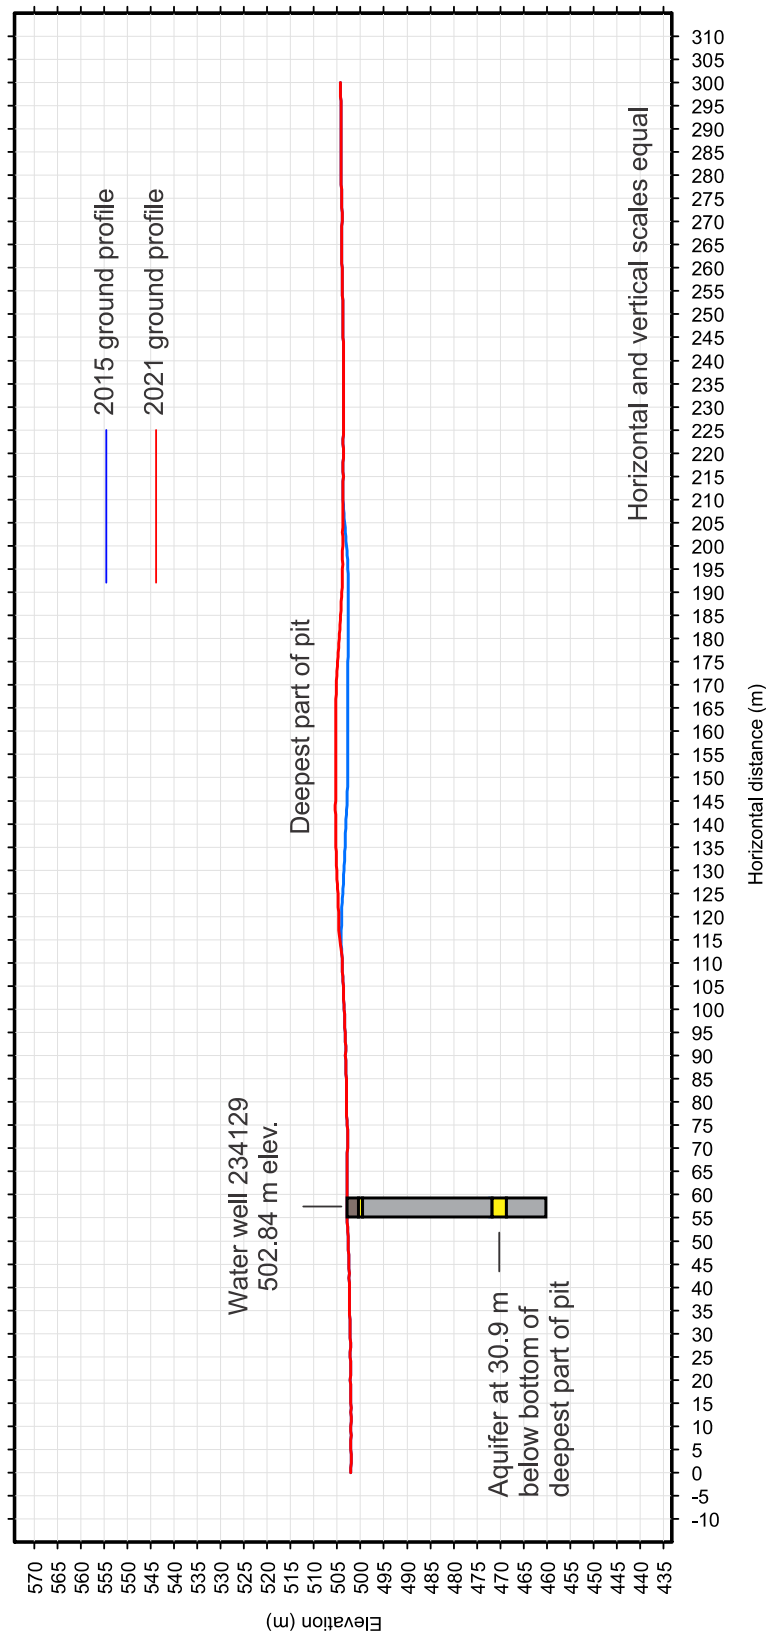
Figure 10 Section A-A' showing deepest part of pit adjacent to water well log (location Fig. 3).

A new figure has been prepared (Fig. 10) to provide additional detail in relation to the question of whether the aggregate development might have any potential to impact groundwater quality or quantity immediately beneath the development site, which was discussed in the Nov 15th memo based on a well situated in SE-10-23-23 W2 (Figs. 8, 9). The figure shows an east-west cross section drawn near the water well, with the section drawn through the deepest part of the deepest of the aggregate extraction zones. Note that the well was not drilled through one of the sand hills, but was drilled through till in the lowland adjacent to the sand hills. The limited thickness of material extracted from the surface during the aggregate development, and the fact that the aquifer where the well has been built is situated 30.9 m beneath the bottom of the deepest part of the nearby pit, it seems unlikely that groundwater in the aquifer immediately beneath the development site will be impacted. The only plausible change would be for possible accentuated recharge of the aquifer due to rainfall and snowmelt infiltrating and flowing into the depression rather than flowing to the wetland.
