MEMO

The memo dated 15 November 2021 that I prepared was prepared prior to receiving briefing on the full range of concerns raised in relation to the aggregate development that occurred this year in SE-10-23-23 W2 (Fig. 1). Specifically, there is concern about the impact of the aggregate development on recharge of the wetland situated immediately downstream (Fig. 2). Water stored in the wetland predominantly during wet spring seasons recharges nearby water wells, including municipal wells at Spring Bay. This memo discusses impacts to drainage patterns associated with the aggregate development that occurred this year.

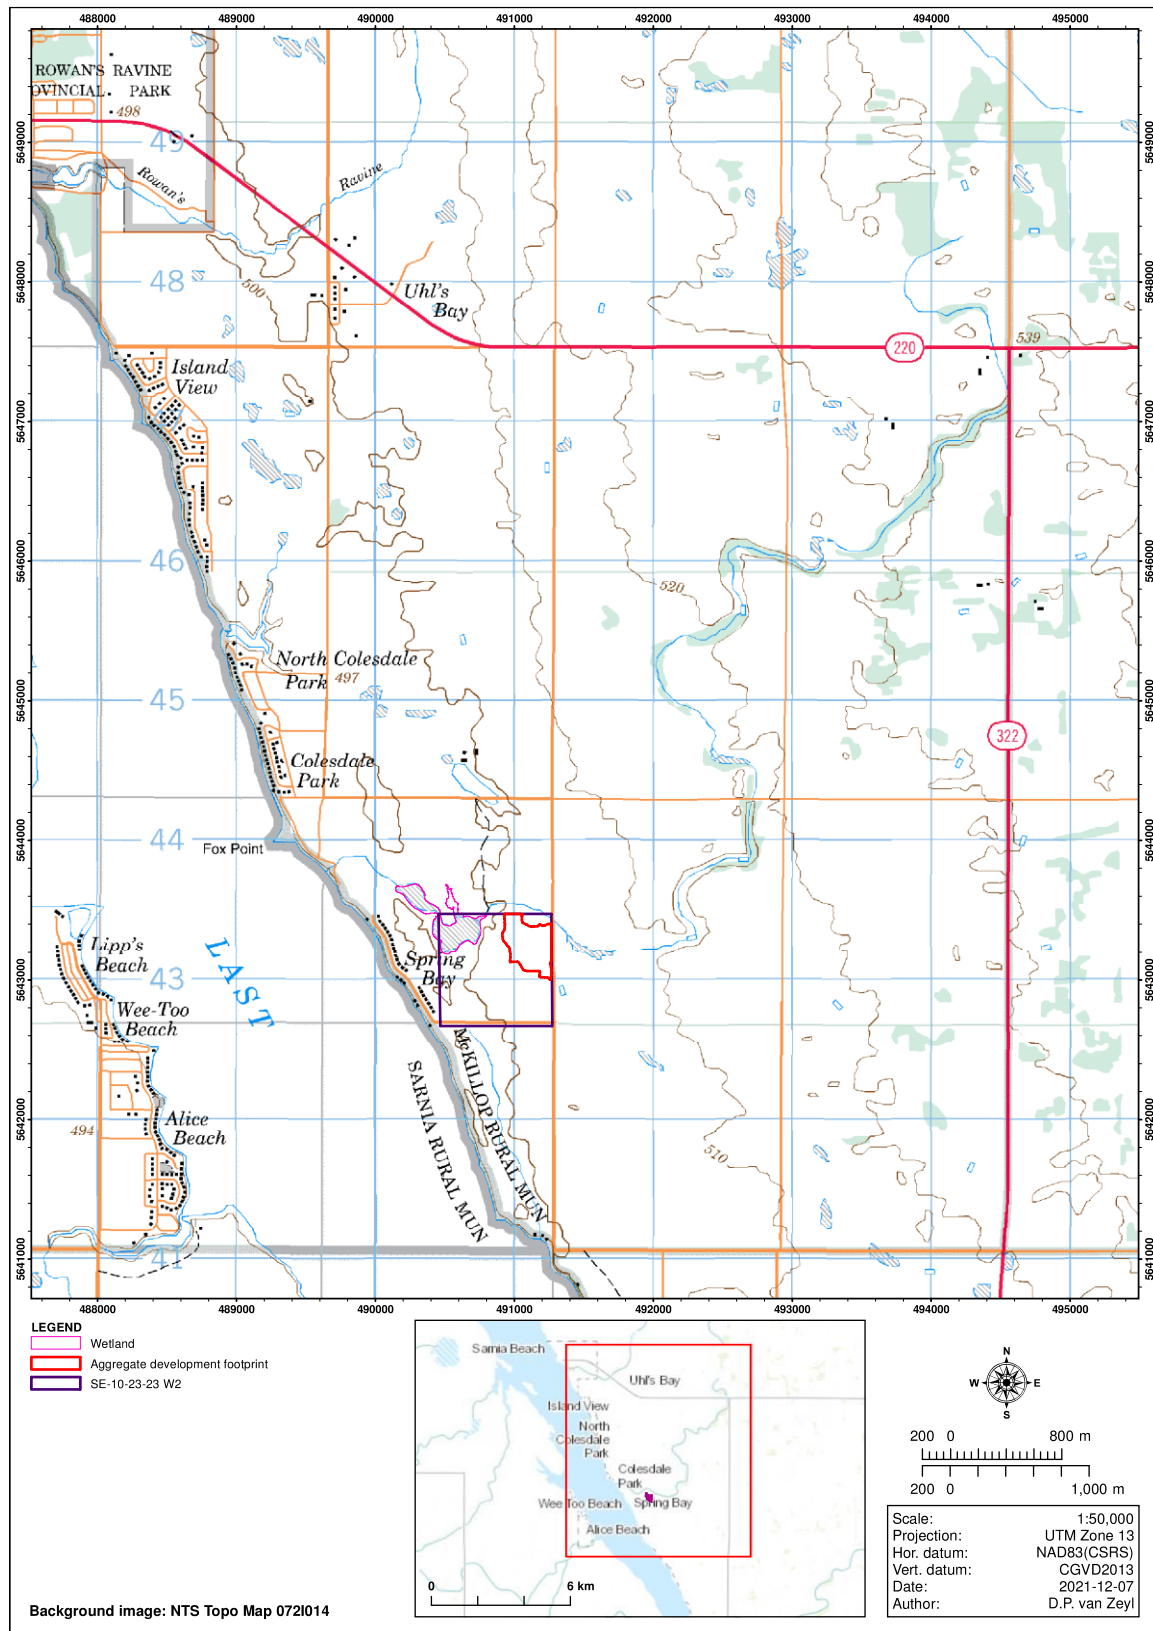
Figure 2 Overview of aggregate development and nearby features discussed in text.

As shown in Figure 2, the wetland extends into all four quarters of section 10-23-23 W2. Moisture conditions were visually assessed in this wetland from satellite images ranging in acquisition date from Apr 1984 to Nov 2021 (Table 1). From these 38 years, only in nine years was the wetland holding significant water in the spring and still holding water in the fall. The driest interval on this record was from 1986 through 1993, when only in 1990 was water visually present in the spring. The wettest period was from 2014 through 2016 when significant water was present both in the spring and in the fall leading into winter.

Other key controls on wetland recharge include the Highways pit in SW-11-23-23 W2 and the north channel situated at the wetland outlet in NW-10-23-23 W2 (Fig. 2). These controls are unrelated to the aggregate development but should be considered so that impacts from the aggregate development can be put into perspective.

The Highways pit in SW-11-23-23 W2 (Fig. 2) was built directly connected to the ephemeral drainage channel. As a result, for every flow that occurs along the drainage channel, the depressions within the pit must first be filled before water can spill out of the pit and flow downstream. The volume of water that must be stored within the pit before downstream flow can occur is 20,470 m³. In contrast, only for flows exceeding 6 m³/s will any water be lost to the pit downstream at SE-10-23-23 W2. For a flow of 6 m³/s at the Highways pit, a volume of 36,145 m³ will be present within the pit depressions, and this volume does not include any headwater effects from the culvert downstream. A larger culvert downstream would reduce the headwater ponding effect and thereby reduce the amount of water lost to infiltration into the road embankment and into the area east of the road.

Channels have been cut in two locations to facilitate drainage of the wetland (Fig. 2), a low-level channel ('north channel') and a high-level channel ('south channel'). The channels are understood to have been built in the late 1960s or early 1970s. The north channel functions as the main outlet for the wetland. The north channel is partially blocked by a makeshift dam built sometime between 2005 and 2009 by SaskTel when an underground cable was installed across the channel (Fig. 2). The sill on the crest of this plug is estimated from the 2015 data as 500.65 m elevation, whereas full supply level on the wetland is estimated as 501.15 m elevation. As a result, if grades near the north channel were restored to their natural state, the wetland would have the capacity to store an additional volume of about 55,840 m³ (wetland area is 111,679 m²). In other words, the impact of the man-made alterations around the north channel have been for the wetland to lose the potential to store an additional 55,840 m³ of water in years when abundant moisture is available. From the satellite image analysis (Table 1), it is expected that losses of at least 55,840 m³ would have been observed in each of the wettest years since 1984, namely, 1996, 1999, 2006, 2007, 2011, 2014, 2015, 2016 and 2017. Prior to the SaskTel plug being installed, these losses would have been much larger, possibly in the order of 150,000 m³. Note that the SaskTel plug is not expected to have been engineered as a dam. Thus, there is a risk that overtopping of this structure could result in its washout and a rapid release of water that could impact the residence at the ravine at the mouth of this drainage (Fig. 2).

In summary, in terms of controls on water supply to the wetland downstream of the aggregate development (Fig. 2), the most important loss of water would appear to be outlet accentuation at the north channel. In years when water is abundant (e.g., 1996, 1999, 2006, 2007, 2011, 2014, 2015, 2016 and 2017), the wetland is losing at least 55,840 m³ of water due to outflow accentuation at the north channel. This would be the number one area to consider for improving wetland water supply and consequent recharge of aquifers in the area of the wetland. The next most important impact identified is the Highways pit in SW-11-23-23 W2, which removes 20,470 m³ of water from the stream before flow is able to continue downstream of the pit. The third most important control is the culvert downstream of the Highways pit. When the small diameter of this culvert results in headwater ponding, some of the ponded water soaks into the road embankment and into the ground surrounding the Highways pit rather than flowing downstream. In contrast, the impact of the aggregate development in SE-11-23-23 W2 on water supply to the wetland is essentially negligible when compared with the above factors. That is, water losses to the wetland from rainfall and snowmelt that used to occur on the sand hills that have now been removed at the aggregate development are in the range of 944 to 4,718 m³ per year, plus there is potential of losing 5,927 m³ at a recurrence interval in the order of 25 to 50 years (based on a discharge that has not been observed at this site in the last 38 years).
